João Boavida and  
Adriano Oliveira,  
Artescan, and  
António Berberan,  
Laboratório Nacional  
de Engenharia Civil,  
Portugal

# Dam monitoring using combined terrestrial imaging systems

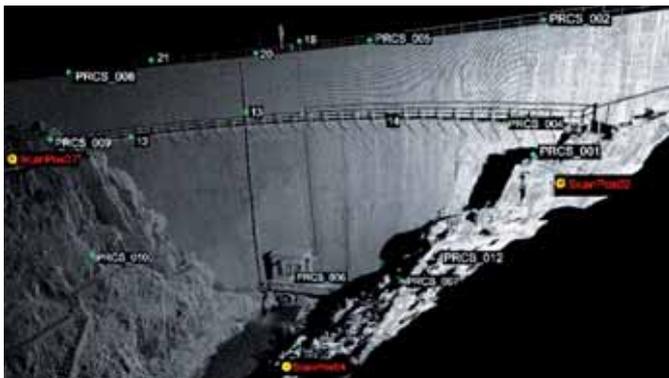
Figure 1: A perspective of the laser intensity 3D model of Alto Ceira dam's downstream face, layout of stations (with red labels) and retro-reflector targets (with white labels).

As full coverage of the dam's downstream face was required, three stations were set up for the laser scanner. Every position produced a cloud of points referenced on an arbitrary instrumental system. In order to get the point clouds referenced in a meaningful reference system, a set of 21 retro-reflector targets were positioned in the dam vicinity (Figure 1).

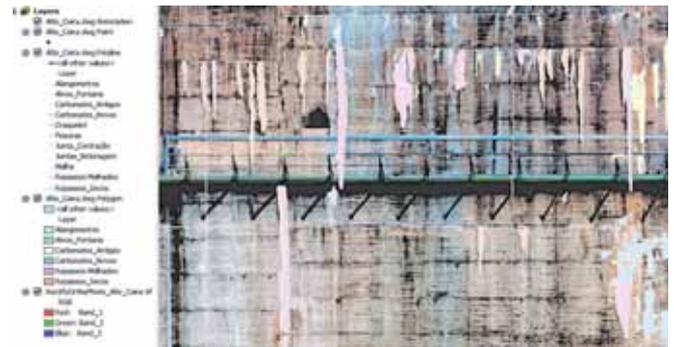
Figure 4: CAD and DBMS technologies were used to get points, vectors and polygons associated with alphanumeric classifications according to an inspection data catalogue.

The scanning was conducted by a team of two specialised surveying engineers and field operations took six hours. The generation of the orthoimage, the vectorisation and codification of the anomalies took 40 hours. Figure 4 illustrates the final result of the codification by association of CAD points, vectors and polygons with their attributes in a database management system environment. Once the anomaly is registered in the assisted visual

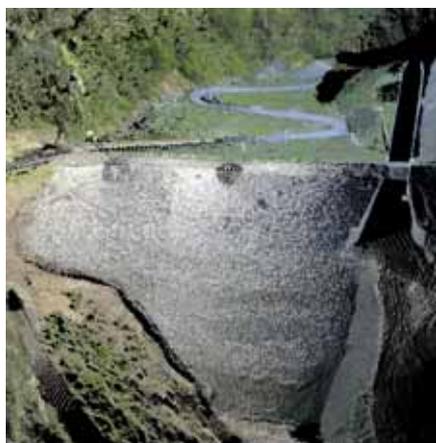
Figure 7: A True colour point cloud.

An imaginary camera can move in a predefined path through 3D models. Dynamic scenarios can simulate the visualisation of an event, like flooding. The true color point clouds (Figure 7) can be a useful document immediately available on site, as it can be visualised in free and user friendly viewers just after the scanning. Figure 9 illustrates the importance and advent of this new type of engineering documents, in this case a mesh, besides profiles and contours.

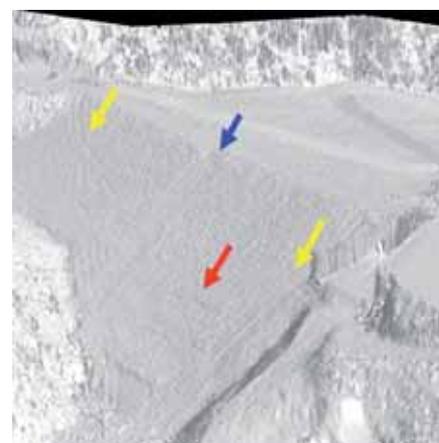
Figure 9: Mesh showing the sliding waves.

None of the phenomena shown on the mesh, whether they are important or not in this particular case, can be easily recognised in conventional engineering documents, and some of them not even on site. At the bottom of the upstream face (red arrow), one strip shows where rocks have been removed (and replaced) to inspect the face of the dam below the rock fill (blue arrow) and two paths left by rolling machinery (yellow arrows).
