# Displacement and surface pathology monitoring of former Tejo Power Station building by combining terrestrial laser scanning, micro-geodesy, photogrammetry and GIS

Adriano OLIVEIRA, João BOAVIDA, Bruno SANTOS, Portugal

The old Tejo Power Station (known as Central Tejo) is a very good example of industrial and architectural heritage from the first half of the 20th century, comprising an impressive iron structure covered in brick. Its production ended in 1972 and in 1986 it was classified as an Asset of Public Interest due to its Industrial Archaeological heritage importance. More recently it was renovated and integrated on the new *Campus Fundação EDP* as the Electricity Museum, in Belém neighbourhood, Lisbon. In 2010, EDP foundation decided to build a modern piece of architecture, the new Museum of Art, Architecture and Technology, (MAAT), just on the adjacent east side of the Electricity Museum.

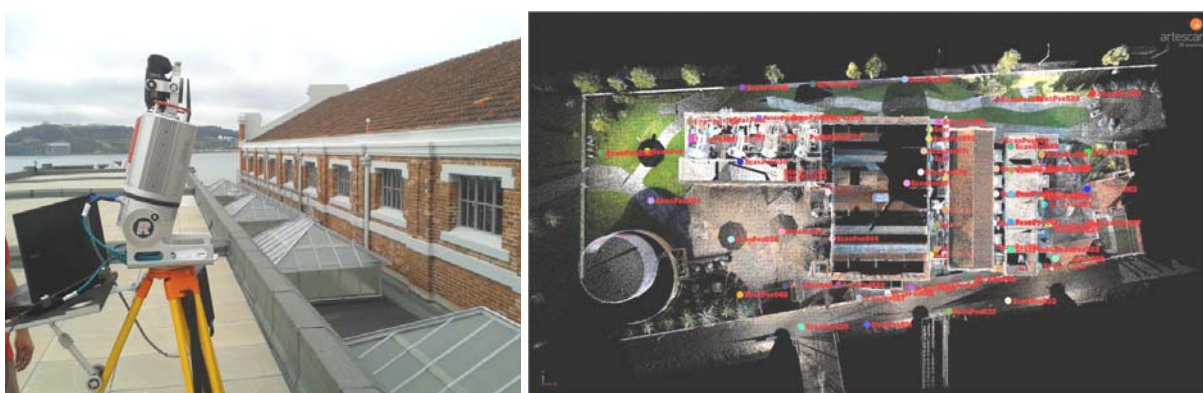
Fig. 3 - TLS and photogrammetric survey acquisition (left) and resulting point cloud (right)

The complete coverage of the buildings complex took 86 laser scanning stations, all around the area under study, as well as on top of the terraces and roofs. For each station, laser data and image were acquired. Point clouds were acquired with a point density on the object of more than 3 cm, and photogrammetric images were acquired with resolution on the object better than 0.8 cm/pixel. The radiometric data acquired by the camera was merged with the geometric data of the TLS, thus providing a coloured point cloud (X, Y, Z, R, G, B).

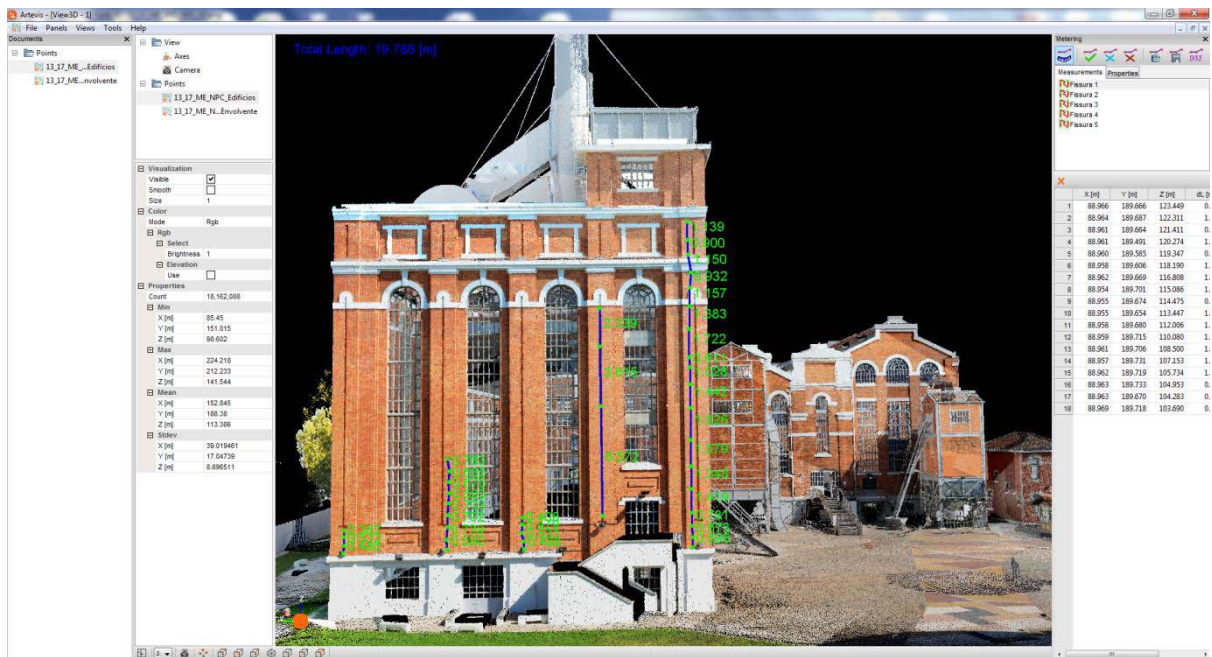
Point cloud registration was accomplished by using retroreflectors as 3D tie points, distributed around the area and surveyed with a digital total station. A unique 3D coloured point cloud was created with a filtered resolution of 1 point every 3 cm. This point cloud can be visualized, analysed and measured using a point cloud visualization software, as *Artevis*.

Fig. 4 - 3D Coloured Point Cloud on Artevis, software for the visualization analysis and measurements of point clouds.

*Artevis* is a software developed by Artescan which allows for the handling of large data sets of 3D point cloud data in an efficient and user friendly way. Within this application it is possible to manage and explore multiple 3D point clouds by conventional 3D controls (move, pan, rotate etc.), to measure coordinate data as well as partial and total distances, to create 3D vectors and to enhance the visualization of the point cloud by using multiple visualization modes (e.g. colouring by elevation or direction).
